DETAILED STUDY
OF THE
SIMCOE COAL GASIFICATION
PLANT SITE

MAY 1991

WASTE MANAGEMENT BRANCH
ONTARIO MINISTRY OF THE ENVIRONMENT

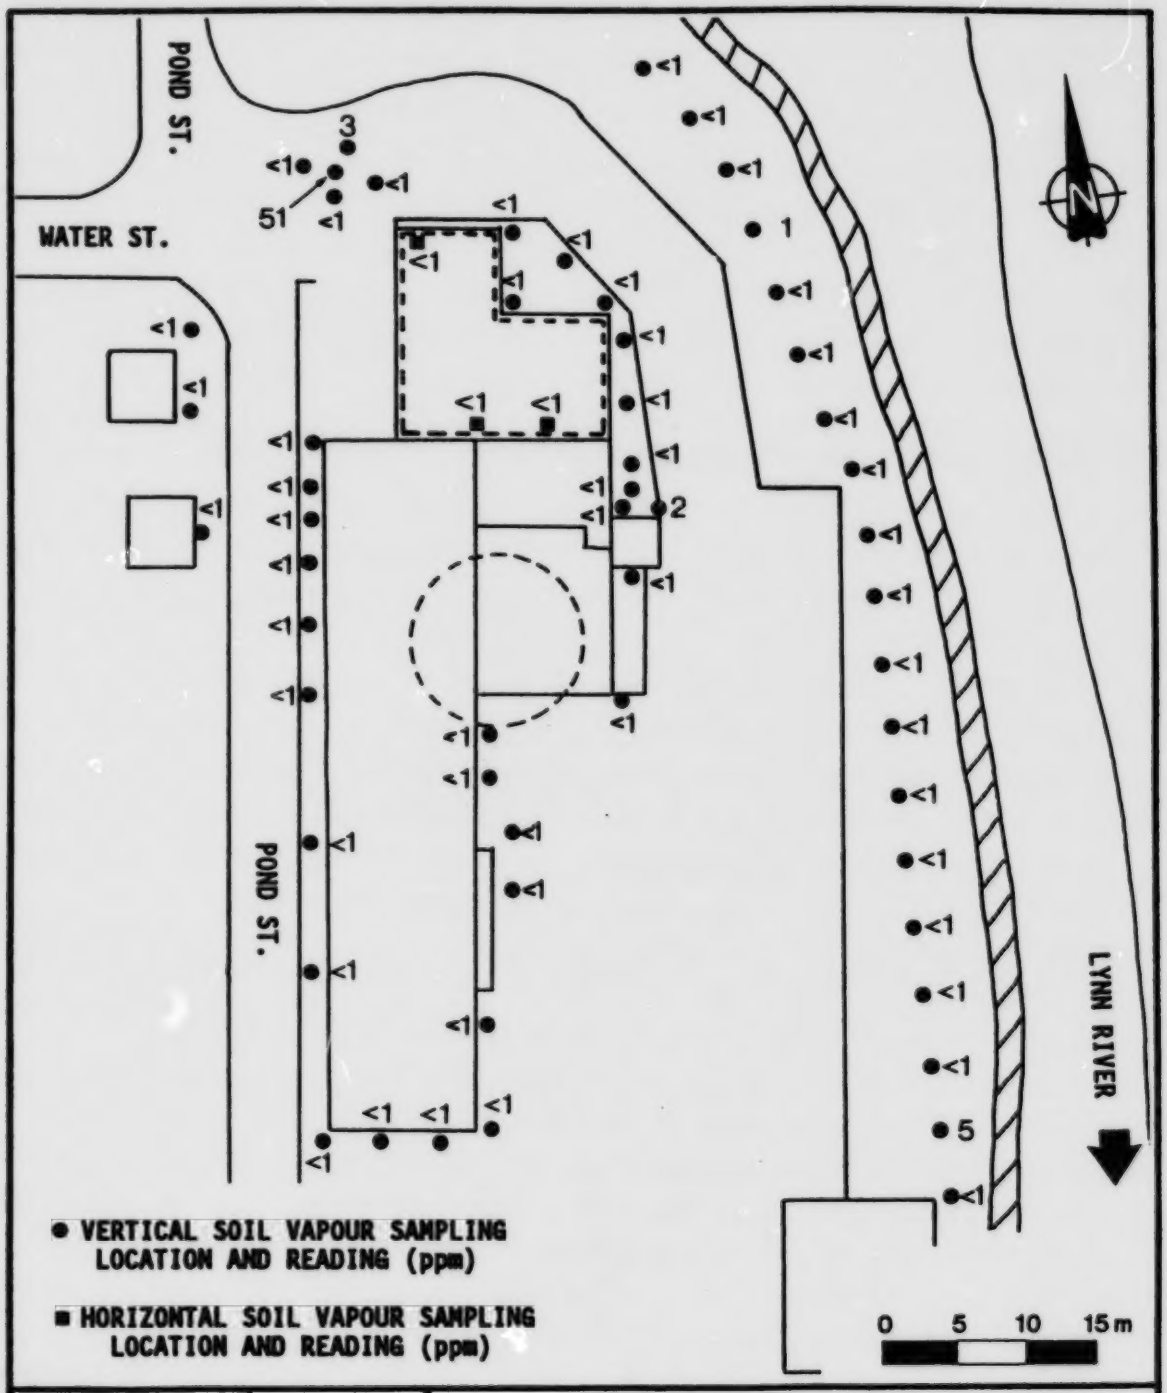
FIGURE 2.2

Soil vapour samples were also collected from the basement of the old gas works building by driving similar sampling pipes horizontally through cracks in basement wall. Soil vapour measurements were made from the north and south sides of the basement walls. Samples collected through the south basement wall were in the direction of the former gas holder. Only background soil vapour concentrations (i.e., < 1 ppm) were measured from the basement of the old gas works building.

RESULTS OF SOIL VAPOUR SURVEY

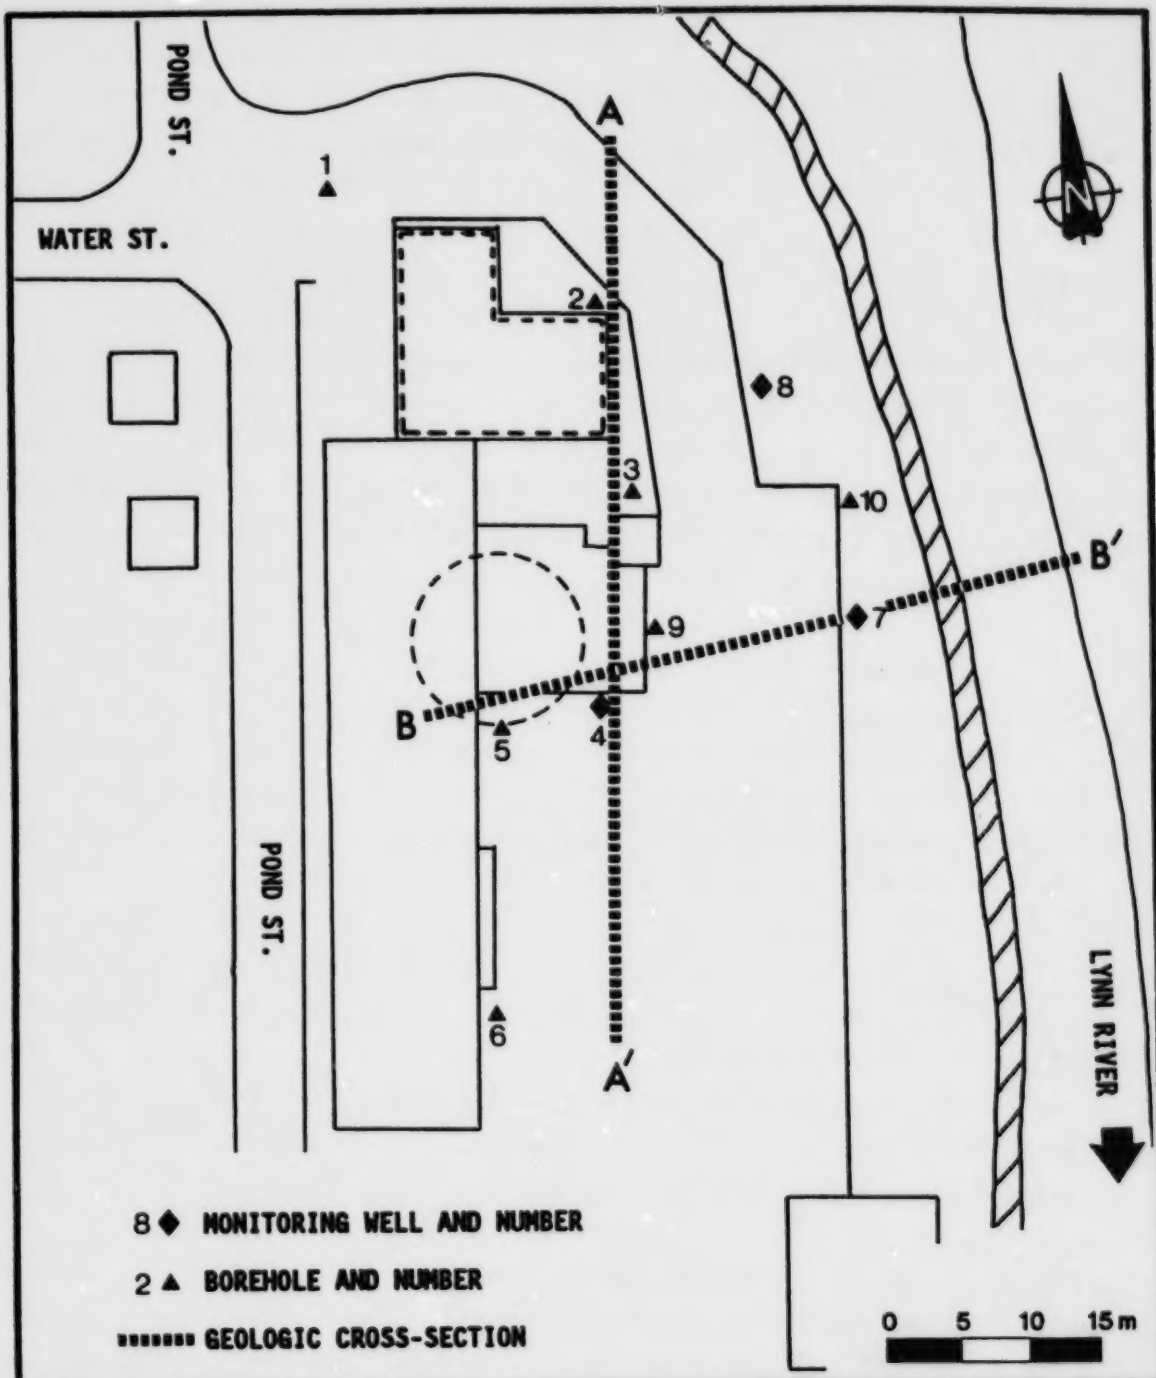
LOCATION OF BOREHOLES, MONITORING WELLS AND GEOLOGIC CROSS SECTIONS

Visual evidence of coal tar contaminants in the form of a purple or blue oily sheen on soil samples and augers was observed during completion of boreholes 3, 8 and 9. Coal tar odours were also detected during drilling of boreholes 2, 3, 7, 8 and 9. The highest OVM readings were measured in boreholes 5 and 9 at 8 ppm. No free product coal tar as residual saturation, as dispersed ganglia or as pools was detected during the drilling program.

A coal tar contaminated soil sample was collected from the fill and peat unit in BH-8 and analyzed for Reg 309 leachate benzo(a)pyrene (B(a)P) to determine disposal requirements for any future excavation at the site. The B(a)P concentrations in the leachate were 101 - 125 ng/g which indicates that the soil, if excavated, would be considered registerable non-hazardous waste and should be disposed at an appropriate landfill as waste class 222N.

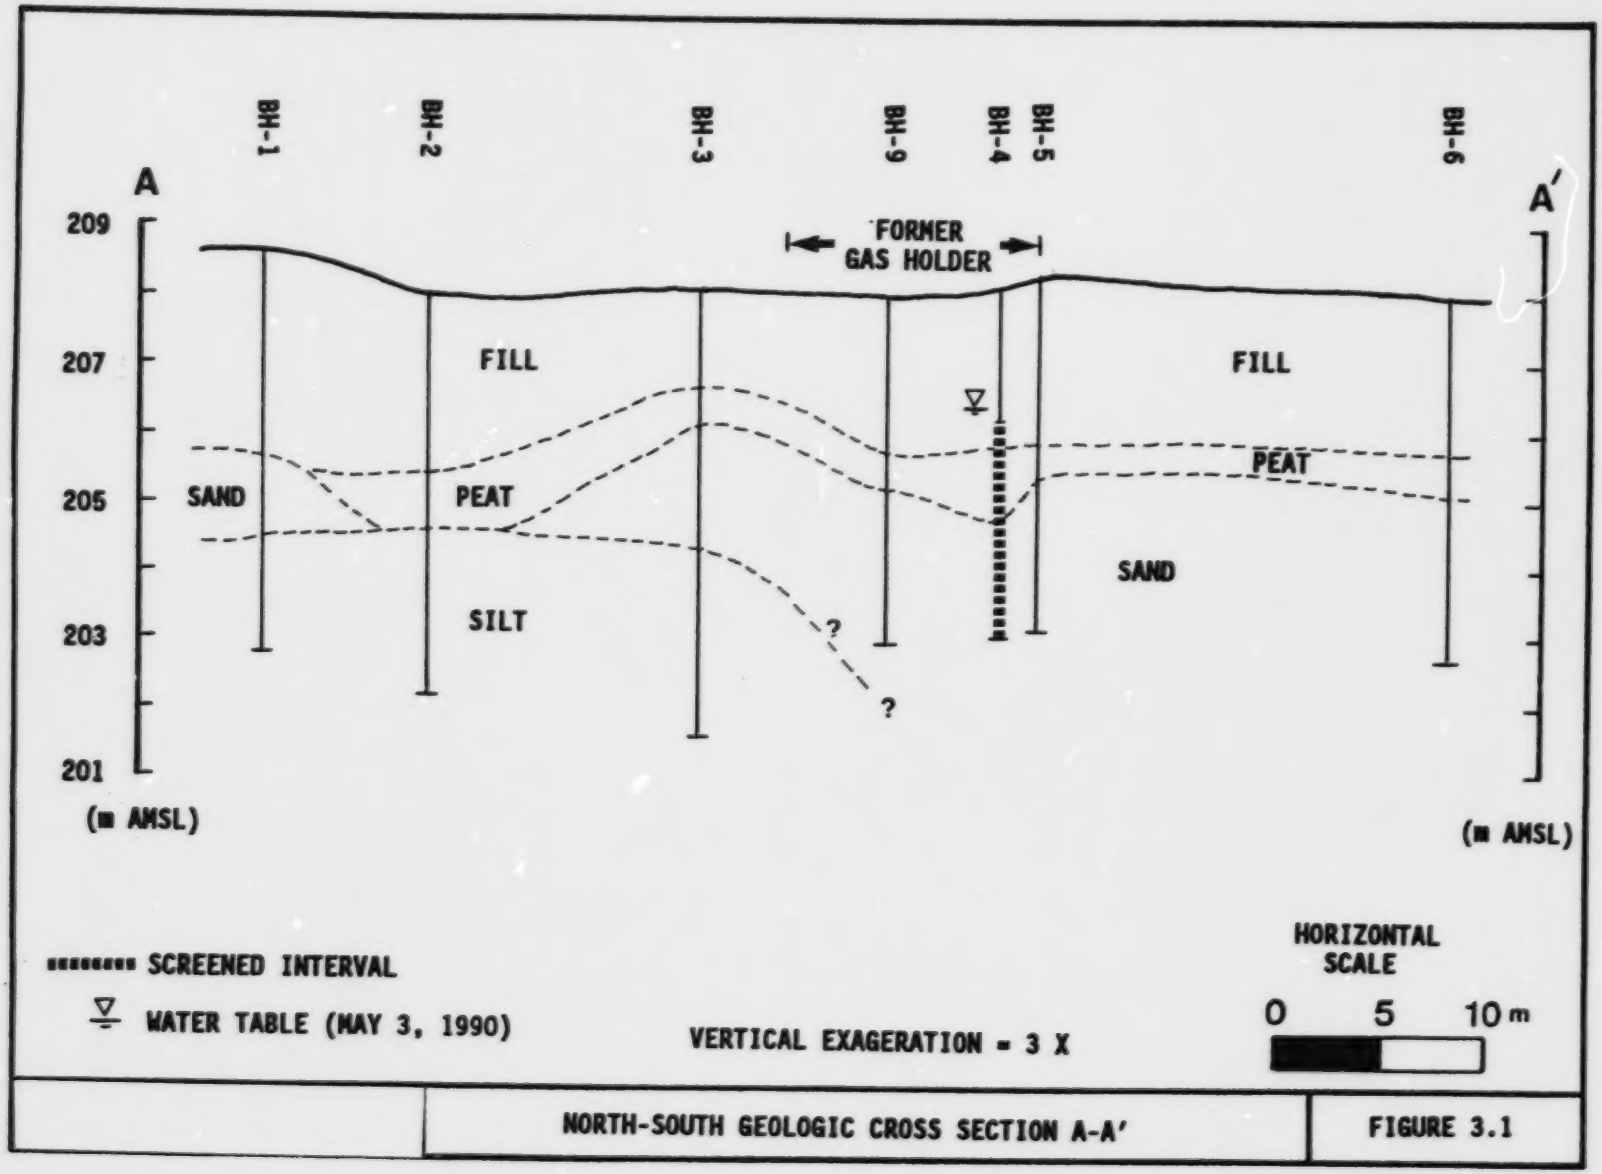
FIGURE 3.1

Figures 3.1 and 3.2 show the local stratigraphy as fill overlying a discontinuous peat layer overlying sand and silt. Over the northeast part of the site in the area of BH 1, 2, 3, 8 and 10 a silt layer underlies the fill, peat and sand. In this area, the sand unit also thins to the northeast from about 2 m thickness at BH-3 to 1 m at BH-1 and BH-8 to 0 m at BH-2 and 10.

NORTH-SOUTH GEOLOGIC CROSS SECTION A-A'

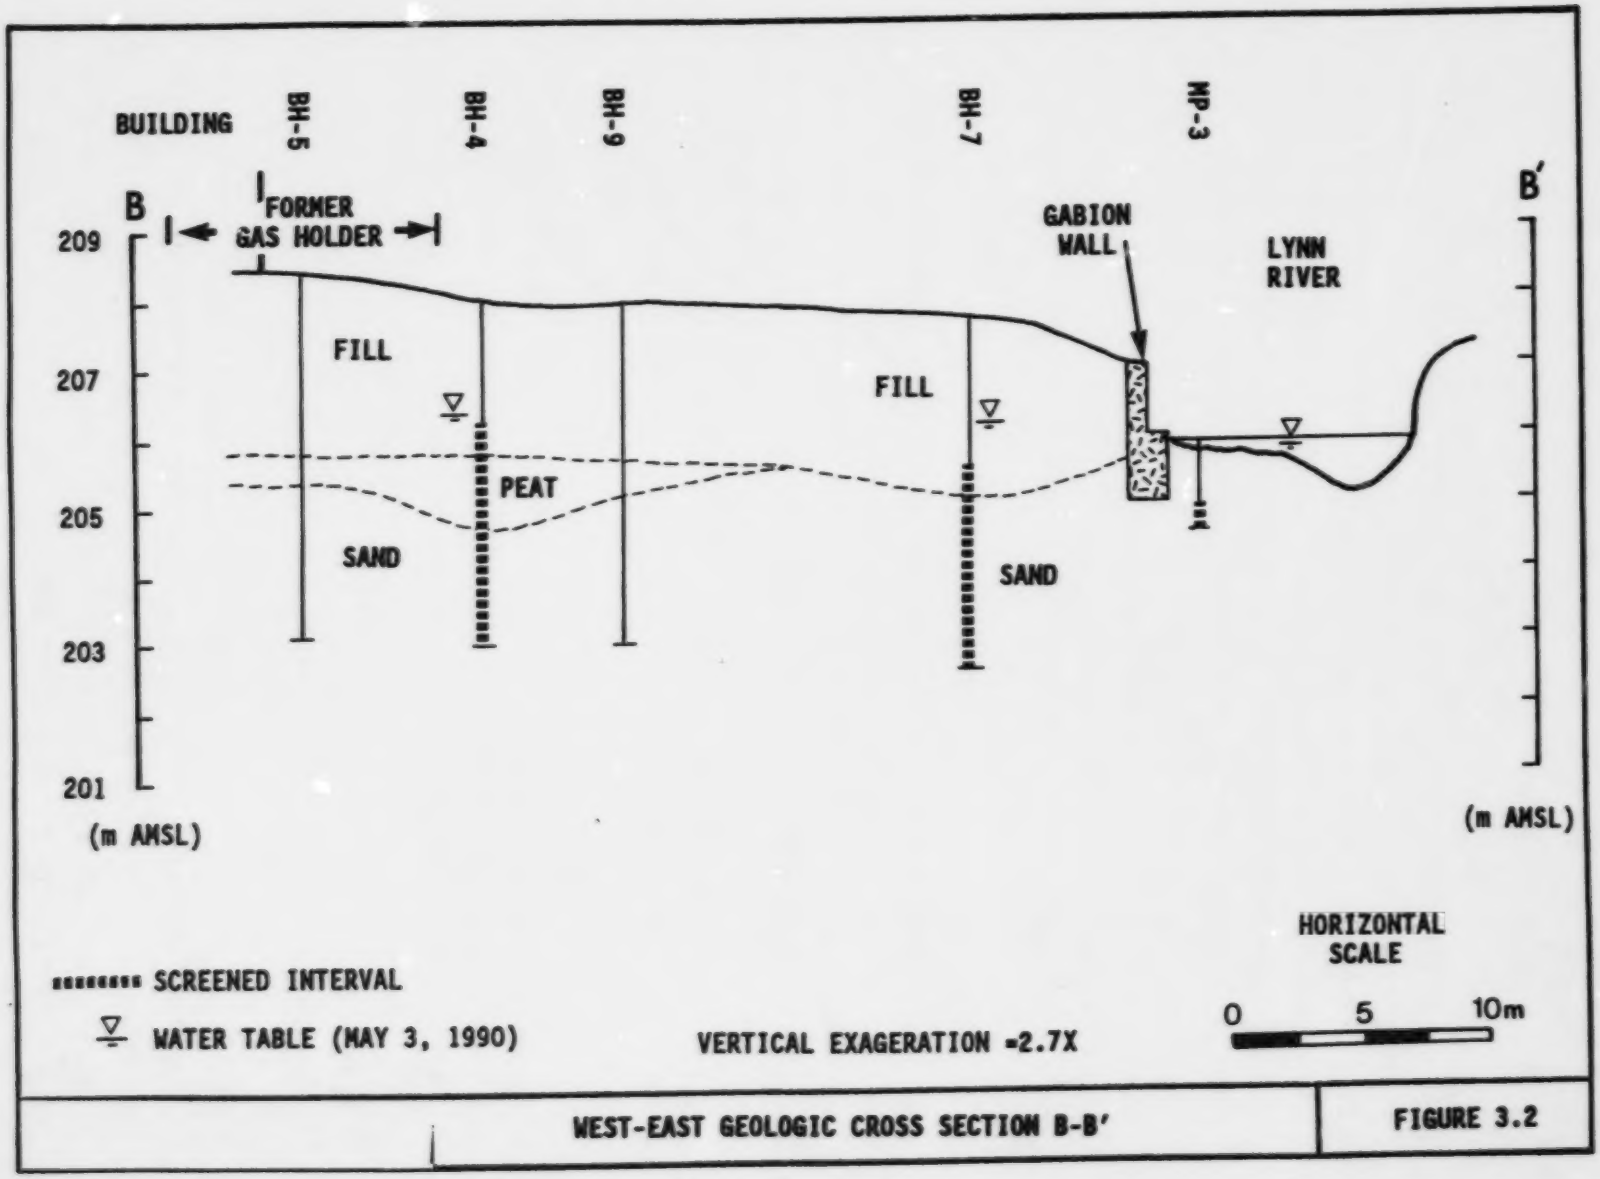
FIGURE 3.2

WEST-EAST GEOLOGIC CROSS SECTION B-B'

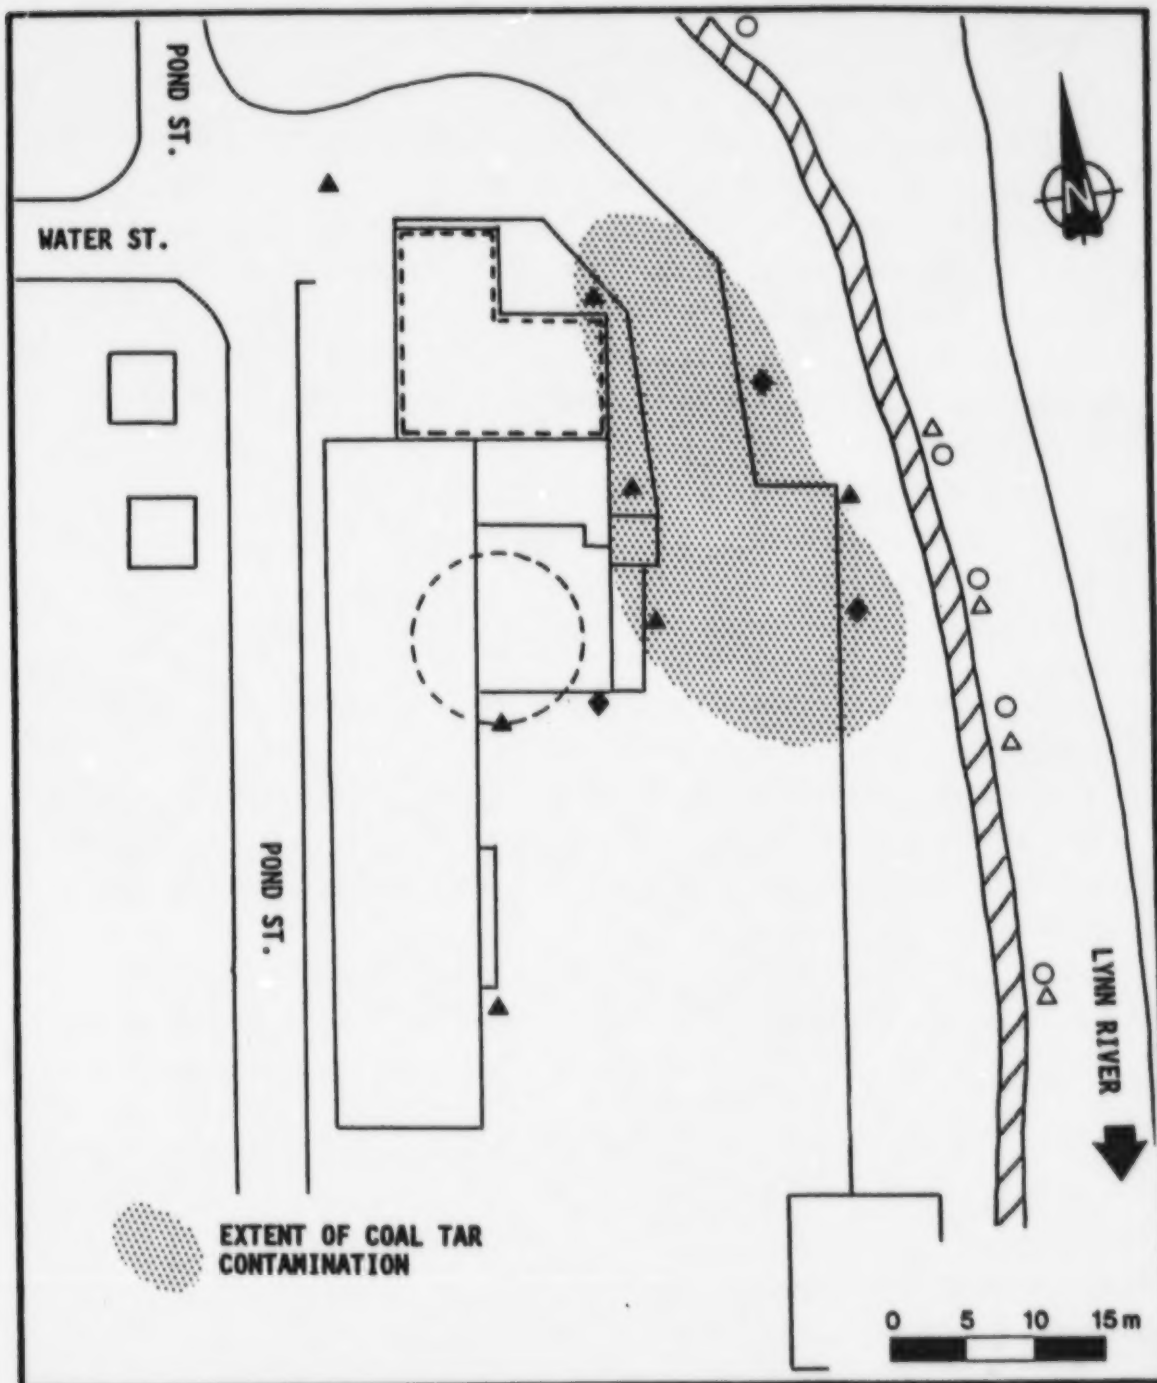
EXTENT OF COAL TAR CONTAMINATION

The results of the site investigations show that a 15 m x 40 m area of coal tar contaminated soil and groundwater exists between the former gas works and the Lynn River. The soil in this area is characterized by adsorbed and immobile coal tar wastes. Groundwater in this area shows trace to low levels of priority PAH and some MAH compounds. No free product or separate phase coal tar was observed on-site.

The available groundwater quality data indicated groundwater contamination only in monitoring wells 7 and 8 and possibly in MP-2. Interpreting similar groundwater conditions for similar soil conditions the

1. The results of this study indicate that the former Simcoe gas works site poses no measurable impact on human health and the environment. Therefore, remediation at this site is not recommended.

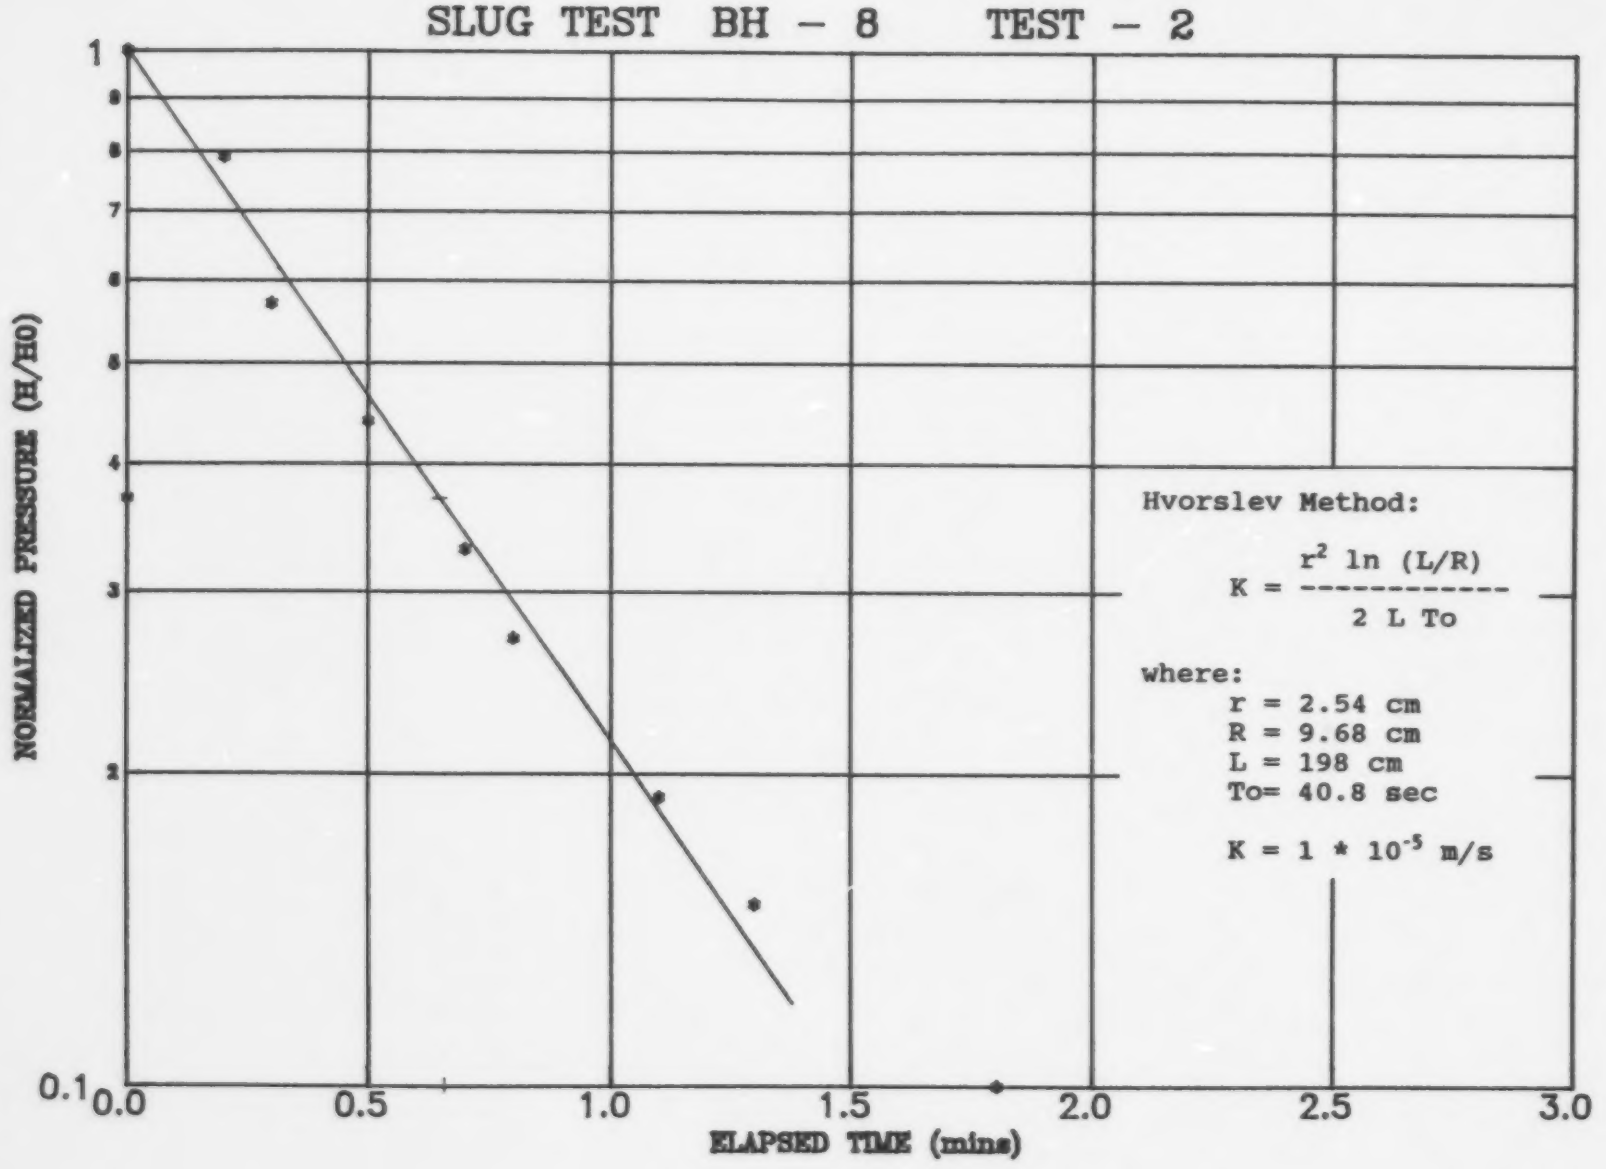
SLUG TEST BH - 8 TEST - 2
NORMALIZED PRESSURE (H/H0)
1
0.1
0.0
0.5
1.0
1.5
2.0
2.5
3.0
ELAPSED TIME (mins)
Hvorslev Method:
K = r² ln (L/R) / 2 L To
where:
r = 2.54 cm
R = 9.68 cm
L = 198 cm
To= 40.8 sec
K = 1 * 10⁻⁵ m/s
